Phase I Report
National Dam Safety Program

NAME: Liguori (Previously identified as Mo No Name 255)

LOCATION: Jefferson County, Missouri

DATE OF INSPECTION: 28 August 1978

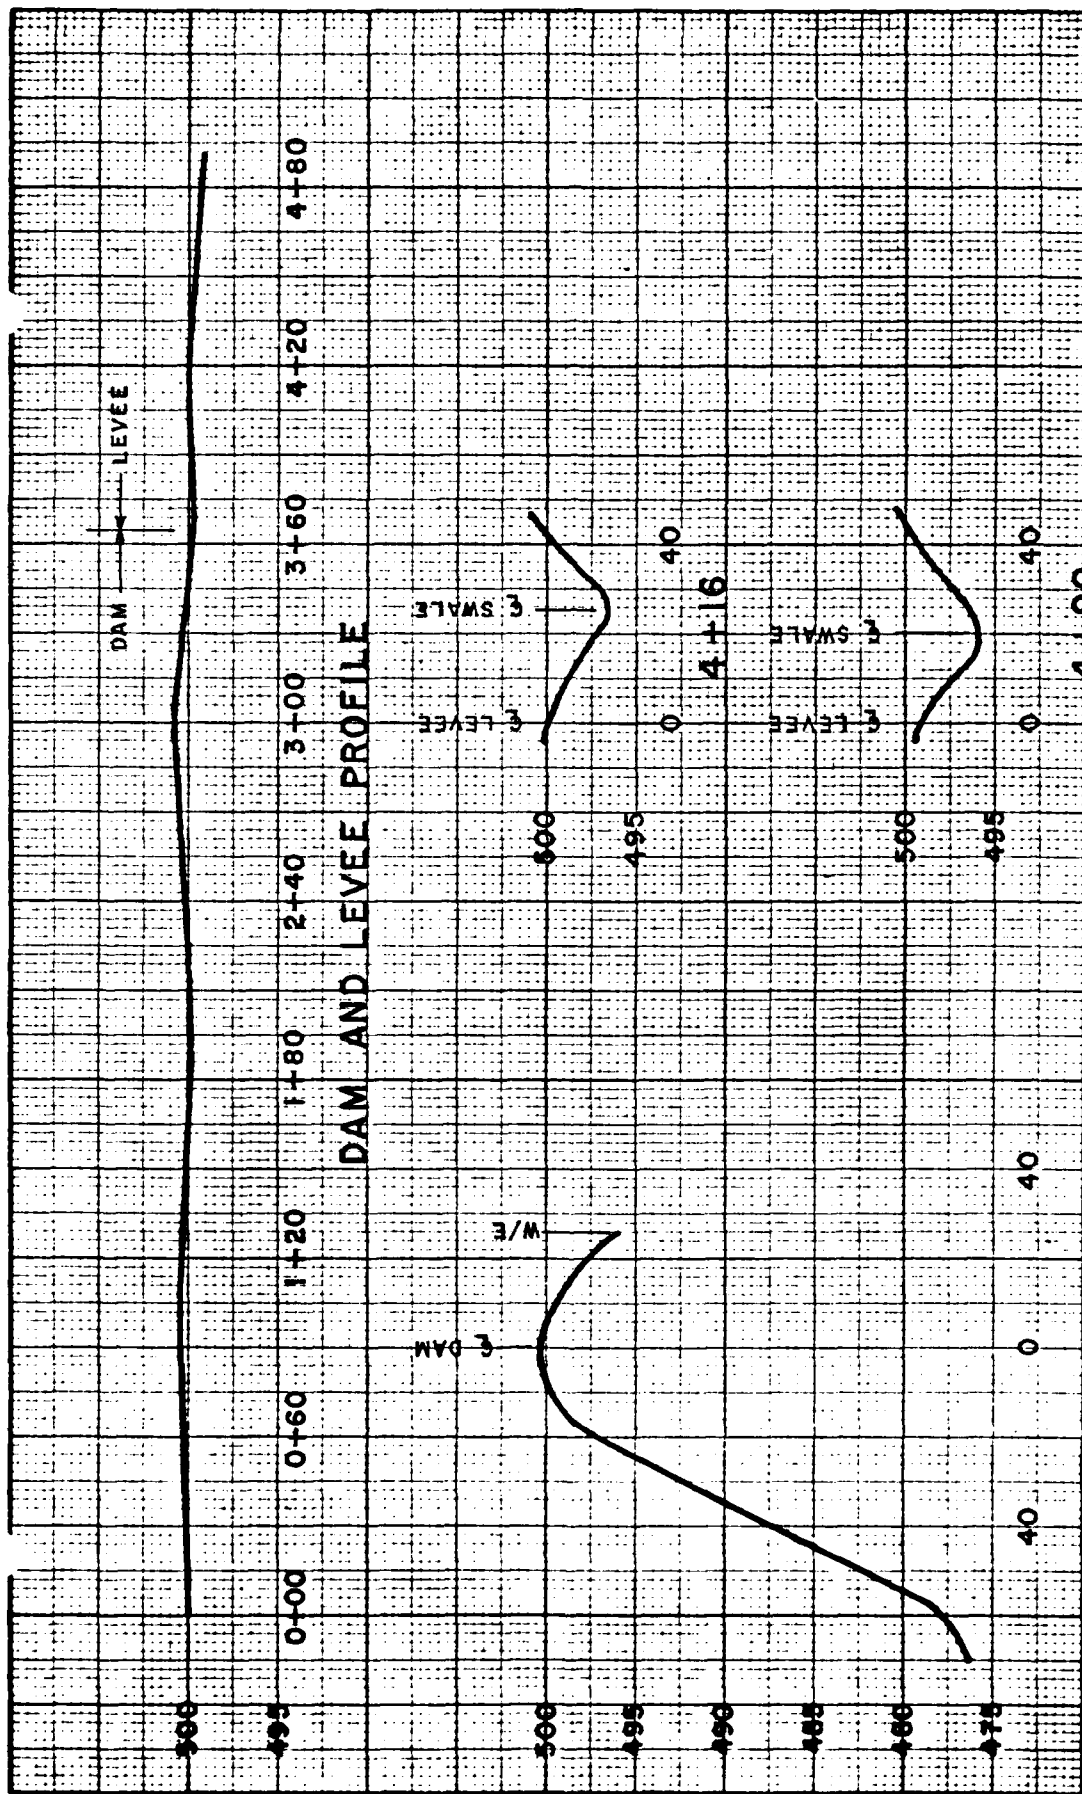
LIGUORI LAKE
 PROFILE AND
 CROSS SECTIONS

Typical embankment slopes are shown on PLATE 4. The crown is relatively wide and gradually rounds into the upstream slope.
